“The Burning Tooth” A Radiographic and Microscopic Study to Aid Identification Process in Fire Disasters

KEYWORDS: Forensic dentistry; Radiographs; Microscopy; Fire disasters

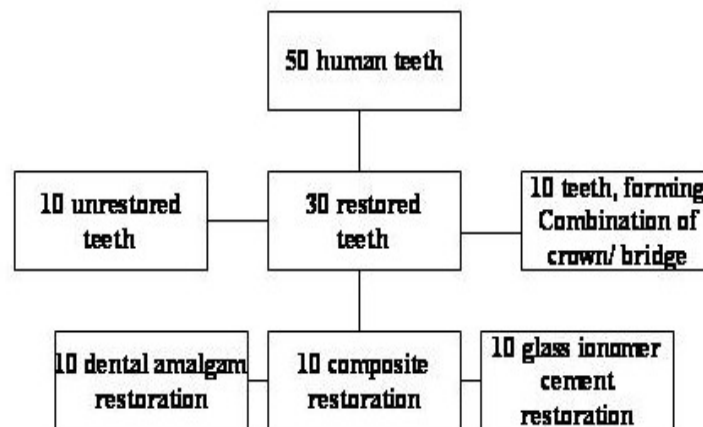
Figure 1, Flow chart which shows the composition of the experimental group.

For the study, fifty healthy human teeth that had been extracted for orthodontic purposes were disinfected for one hour in a 5% sodium hypochlorite solution and kept at room temperature in formalin solution.(Fig. 1).

The study group was divided into three groups. (1) Normal unrestored teeth (n= 10), (2) teeth restored with silver amalgam, composite and GIC type II (n= 10 in each subgroup) and (3) teeth restored with crown and bridge (n=10). All the cavity and tooth preparations were performed as per the guidelines in the phantom head laboratory and strict clinical protocols were observed in the fabrication and insertion of restoration.

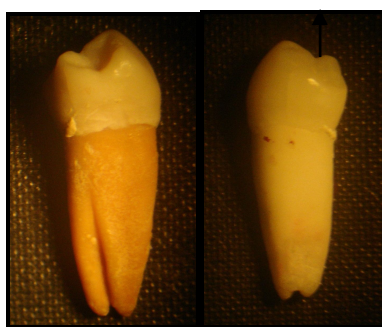
Fig 3

Fig. 3, showing loss of cementum in tooth after an exposure at 250° c
 Fig. 4, showing fracture line development along with crown damages at 550° c
 Fig. 5, showing fracture lines in dentin along with crown detachment at 850° c

Temperatures (in degree C)	Microscopic observations	Radiographic observations
250 (direct exposure)	No changes in crown Cementum lost from root(fig 3)	No changes in crown Cementum loss not appreciable
550 (direct exposure)	Crown appears burnt off with loss of enamel Root- burnt off, chalky appearance	Fissure between enamel & dentin, with crown destruction Root- changes not seen (fig 4)
850 (direct exposure)	Enamel tearing off, chalky Crown fracture & detachment Root- dentine tearing off Root changes better appreciated	Fractures between enamel/ dentin, crown detachment Root- fissures/ cracks within dentin (fig 5)
1150 (direct exposure)	Fractured crown, reduced in size and shape, Root- large cracks & chalky, brittle surface (fig 6)	Large fracture lines through crown Root- numerous fracture lines seen, but still maintaining the shape
250- 1150 (gradual rise)	Tooth broken down in fragments Whitish chalky shattered appearance	Crown reduced in fragments Roots broken down in half Tooth appears more damaged(fig 7)

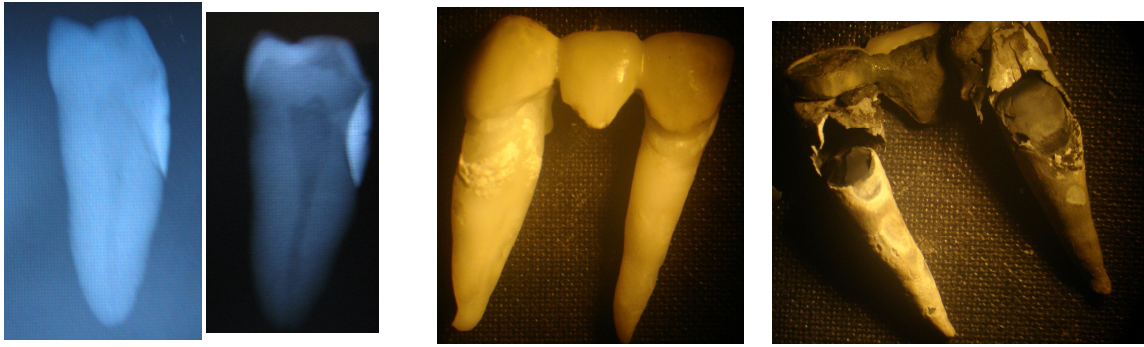
Fig. 8 : Initial development of crack evident at tooth- restoration interface at an exposure of 250 ° C

Fig 9: Development of fine crack within GIC restoration, at an exposure of 250 °C

Fig. 10 : Crown & bridge restoration partially detached from crown along with leuting agent remained (GIC-1), restoration intact at an exposure

Temp In ° C	Appearance	Dental amalgam	GIC	Composite	Crown & Bridges
250, direct exposure	Radiologic	No changes	No changes	slight development of crack evident at tooth- restoration interface (Fig. 8)	No changes
	Microscopic	No changes	Development of fine crack within restoration. (Fig. 9)	Slight separation evident	No changes
550, direct exposure	Radiologic	Large fissures between dental tissue and fillings— One tooth showed the restoration detachment	Restoration intact except for development of fine cracks evident both radiologically & microscopically	Total detachment of restoration , with no evidence of it	Restoration partially detached from crown along with leutting agent(GIC1), restoration intact
	Microscopic	Cracks seen at tooth restoration interface.		Restoration burnt off except for fine particles still adhering to tooth	-do- (Fig. 10)
850, direct exposure	Radiologic	Detachment of restoration from crown, restoration still in shape, (even in samples with detachment of crown and fillings). (Fig. 11)	No traces of restoration seen, a line of fracture in radicular dentin seen below cavity area	Crown detached from root, no particles of restoration seen in burnt remains as well	Restoration intact, totally detached from tooth along with a cap of enamel, dentin and peeling off of the tooth structure.

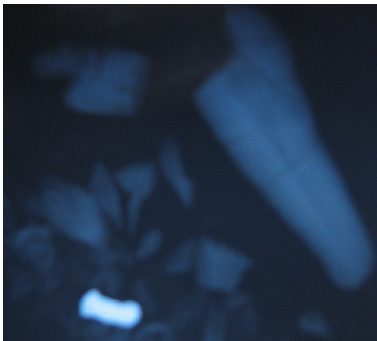
Fig.11 Detachment of dental amalgam restoration from crown, restoration still in shape, at an exposure of 850 ° C

At 850°C, all the restorations got totally separated from the teeth, with amalgam restoration still maintaining its shape in detached crown. GIC restoration got totally burnt off leaving a void at the cavity

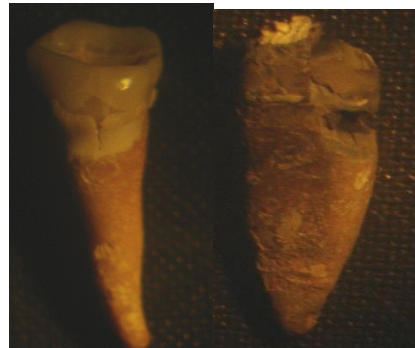
Fig.12 GIC restoration burnt off totally, detached from tooth surface, creation of void at place of restoration at an exposure of 850° C

Microscopic	Burnt off appearance of restoration along with Detachment of restoration from crown	Restoration burnt off totally, detached from tooth surface, creation of void at place of restoration. (Fig. 12)	No evidence of restoration, crown shattered	-do-
1150, direct exposure	Radiologic	Restoration fragmented, Crowns reduced in fragment	Crowns reduced in fragments, restoration not appreciable	Tooth shattered in fragments, no evidence of restoration	Ceramic fracture could not be appreciated
	Microscopic	Crown shattered, restoration cracked and mixed among remains	-do-	-do-	Restoration intact, tooth totally shattered, ceramic part got fractured.
250-1150, gradual rise	Radiologic	Restoration fragmented, separated from crown. Crowns reduced in fragment	Crowns reduced in fragments, restoration not appreciable	Tooth shattered in fragments, restoration not appreciable	Restoration intact, tooth totally shattered (Fig. 13)

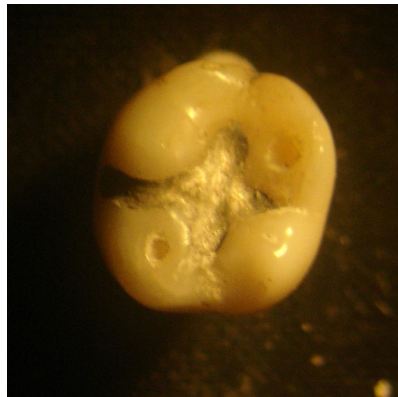
Fig. 14 : Showing unaffected appearance of amalgam restoration at a temperature of 250°C

being exposed to heat directly. We did our best to replicate the same conditions that might be present in different fire disasters within the constraints of our "in vitro" investigation. With the exception of the loss of cementum shown in microphotographs of nearly all the samples, no changes were noted by radiographic examination at 250°C between the unrestored and restored teeth. [Fig. 14].

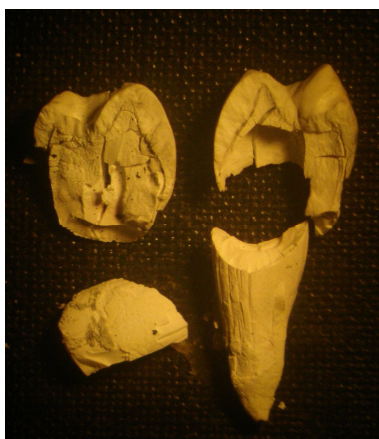
Fig. 16: Showing shattered, detached & fragmented tooth at a gradual rise of temperature from 250^o C to 1150^o C

All of the teeth displayed crown detachment after being exposed to a direct heat of 11500 C, and the crowns were reduced to little fragments. As seen on radiography and microphotographs, roots were also broken. When the teeth were exposed to a gradual temperature increase from 2500 C to 11500 C, similar outcomes were achieved. But there was more distortion across the entire clip. (Fig. 16).
